Developing NDE Techniques for Large Cryogenic Tanks

Year 2 Report

Ellen Arens, Robert Youngquist, NASA, KSC Applied Physics Lab
Judy McFall, Steve Simmons, Robert Cox, Arctic Slope Research
Corporation

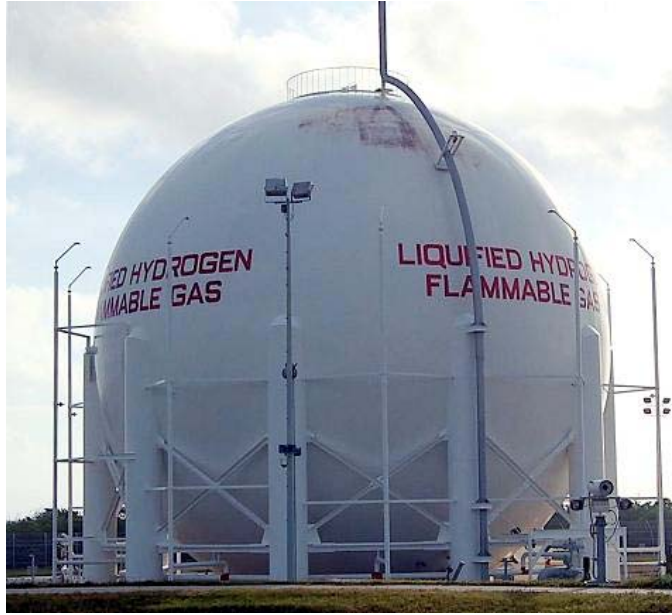
Figure 1: LC-39 Pad B tank; “cold spot” near the top of the tank by the vent line

LC-39 cryogenic hydrogen storage tanks are 70 feet diameter double walled spherical tanks with granular perlite insulation in the annular region between the tanks. Thermal imaging has been used in the past to investigate an anomalous region on the west side of the Pad B LH2 tank. This region is visually detectable due to mold growth on the tank surface as seen in Figure 1. This area is much colder than the surrounding tank surface and has been proven to be due to a perlite insulation void below the surface in the annular region between the inner and outer shells. The additional heat flow through this region of the tank caused a significantly higher hydrogen loss rate on the Pad B tank as compared to the Pad A tank. With the poor performance history and the need to perform facility repairs and modifications, the Pad B LH2 tank was approved for refurbishment efforts begun in 2009. The anomaly on the west side of the tank and the availability inspect the annular region of the tank as refurbishment began made the Pad B LH2 tank the perfect vessel for demonstration of NDE techniques.

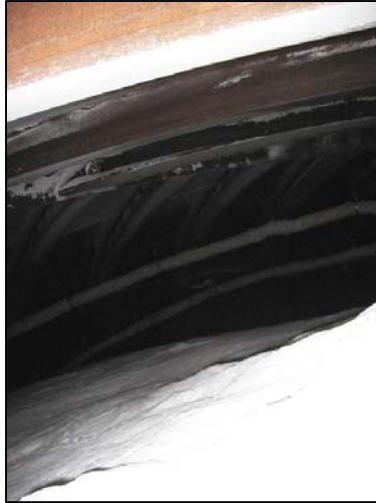
Figure 5: Annular region void space

The anomalous region on the west side of the Pad B LH2 tank was imaged throughout the warm-up phase of the tank drain operation. The void size and shape determined from the bore-scope inspections corresponds well with previous thermal images taken of the area. Figure 5 shows one of the images obtained from bore-scope inspections giving an indication of the size of the void space. Figure 6 shows a thermal image of the tank from March 8, 2010 showing the outline of the “cold spot” on the tank. The bore-scope inspections revealed that much of the area had some percentage of insulation over the inner vessel, however the area below the mold growth on the outer tank shell had only a light dusting of insulation so that the inner tank was effective exposed in this area.

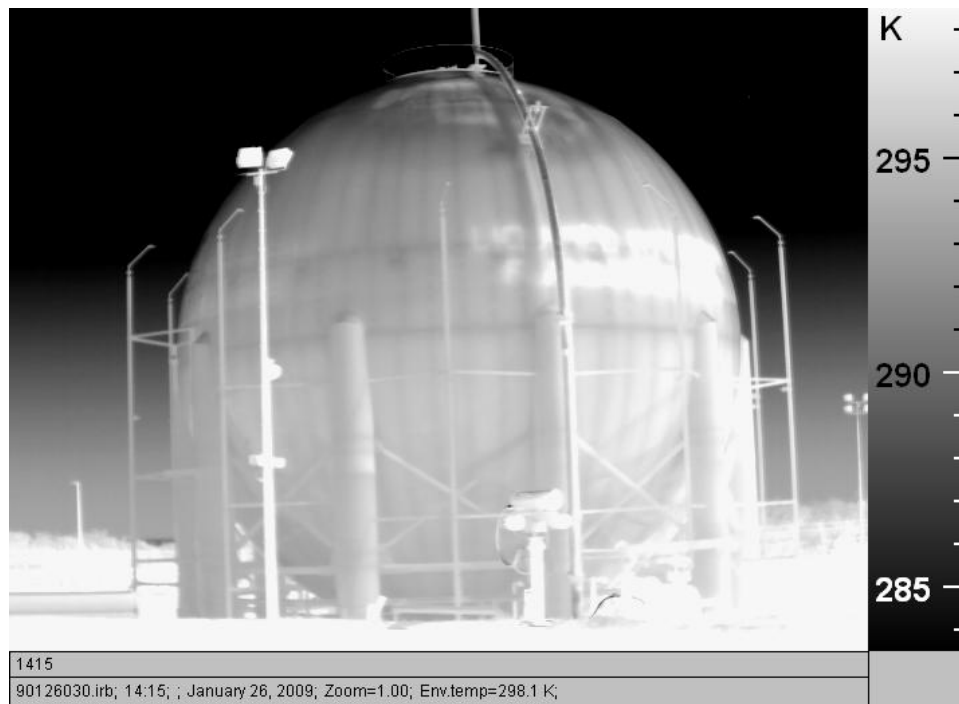
Figure 7. The image was taken on January 26, 2009 at 2:15 PM with a Jenoptik VarioCam LWIR camera. Liquid hydrogen remained in the tank and the annular region pressure was $< 1\text{e-}5$ Torr.

Thermal images were obtained throughout the drain of the liquid hydrogen from the Pad B tank and during the warm-up period. The following sequence of images shows the void region when the tank

contained liquid hydrogen, when it was drained of liquid hydrogen but below ambient temperatures, and after the system was warmed to ambient conditions (following bore-scope inspections). The sequence of images indicates that the void region is still detectable even when the cryogen is not present. As the model predicts for a tank with an outer shell of carbon steel and a corrosion layer on the inner side of the vessel (resulting in an increased thermal emissivity) with a stainless steel inner vessel, a few degrees temperature difference was detectable. This field data differs from the model due to many factors including the differences in spherical vs. flat plate geometry, variations in sun angle, cloud cover, and wind speed. Though differences exist, the combination of theoretical and observed temperature differences give evidence that thermography may be a viable technique for void detection depending on tank geometry and the environmental conditions under which images are obtained.

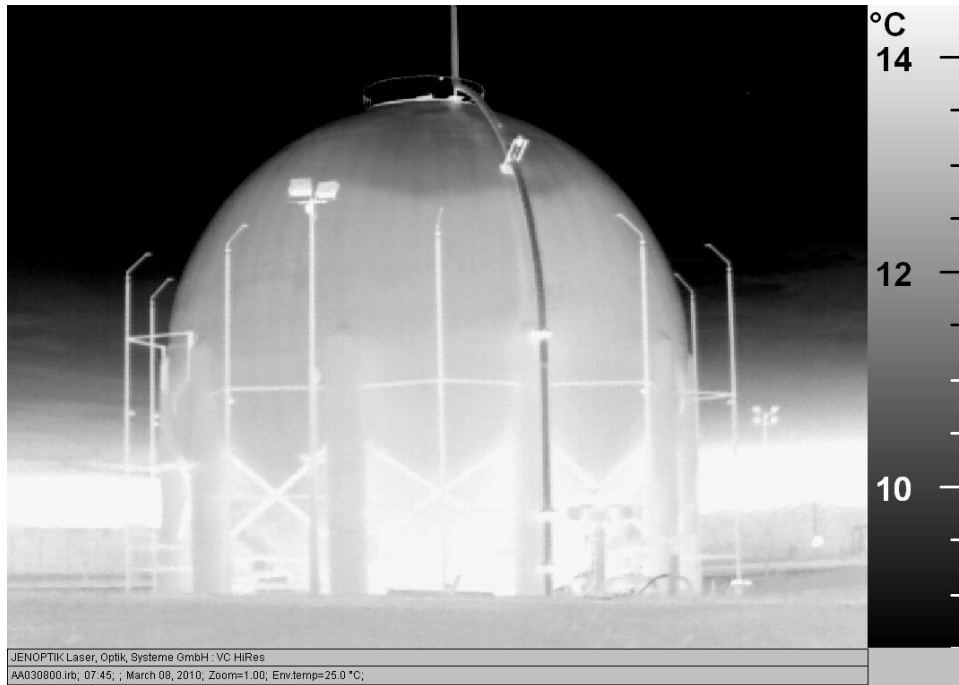
Figure 8. The image was taken on March 9, 2010 with a Jenoptik VarioCam LWIR camera. The inner tank temperature was approximately 6°F and annulus pressure was 3.5 PSIA. Overcast skies provided for good imaging as the moldy area did not absorb heat as readily as with direct sunlight and therefore did not mask the visibility of the cold spot.

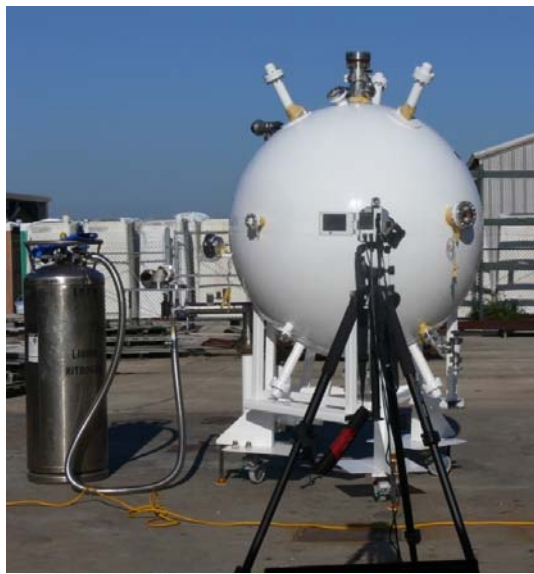
Figure 10: Imaging location for 5-foot diameter double walled cryogenic storage tank.

A smaller five-foot diameter liquid nitrogen tank of spherical design with stainless steel inner and outer shells, shown in Figure 10, was used to perform a similar imaging sequence as that performed on the Pad B tank. We had the ability with the small tank to create an artificial void to image by only filling the annular region half way with insulation.
